# Cost/Benefit Analysis of the Effectiveness of Crack Sealing Techniques

University of Minnesota Duluth

Research Report

Final Report 2019-26

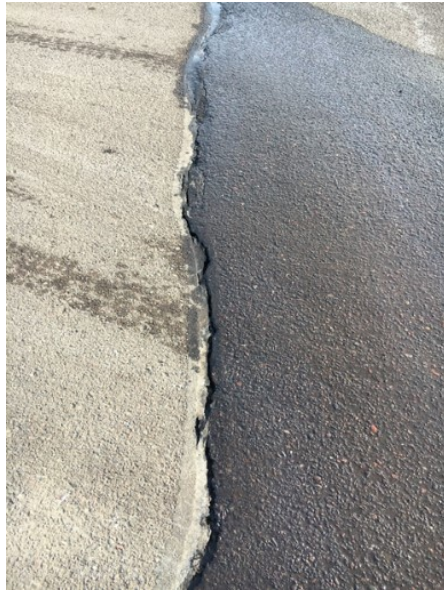
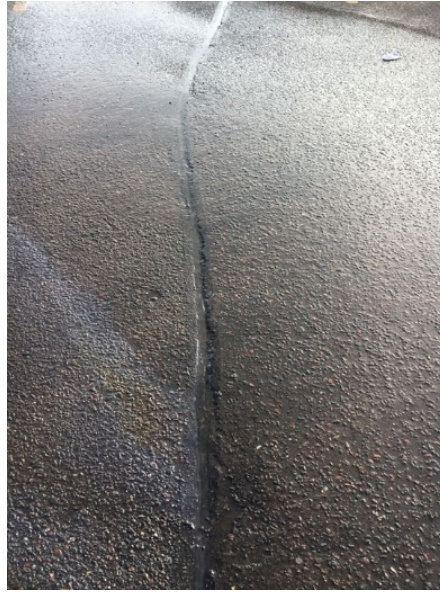
(a) Failed Crack Seal

(b) Intact Crack Seal

**Figure 1.1 Photographs Show the Benefits of Effective Crack Seal**

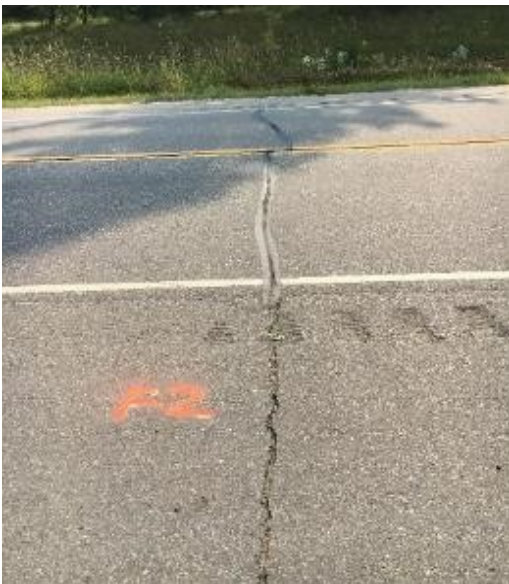
**Figure 1.2 Photograph of a Transverse Crack**

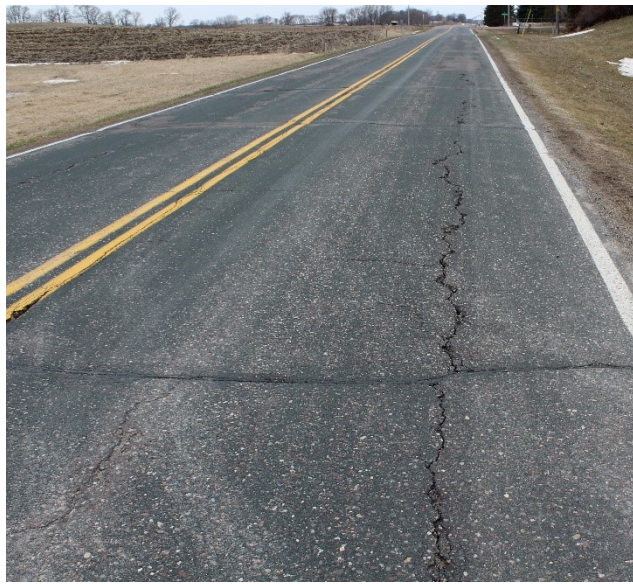
**Figure 1.3 Photograph of a Longitudinal Crack**

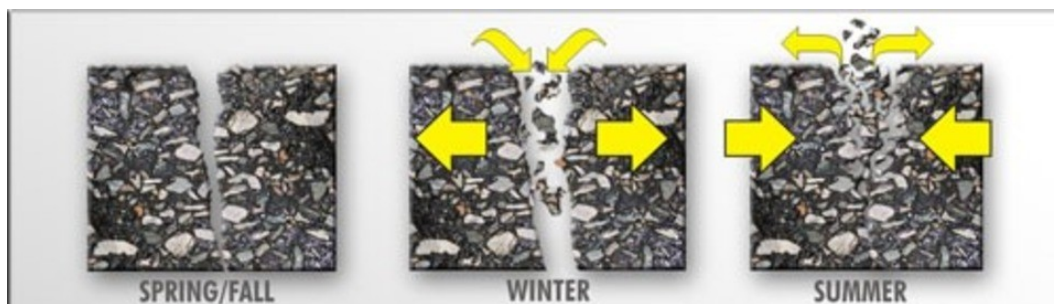
**Figure 2.2: Incompressibles Intrusion Related Damage (after, Stoikes, 2017)**

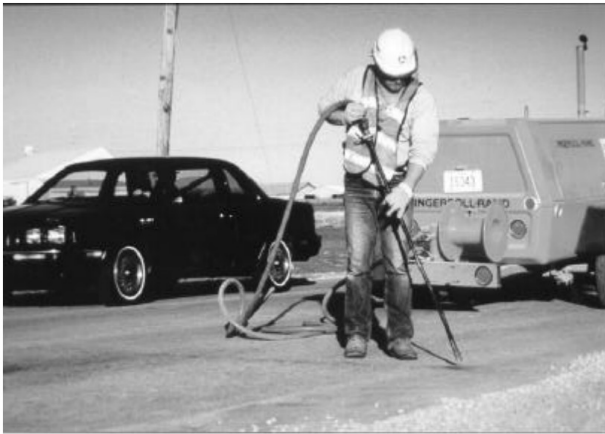
Figure 2.4: Airblaster Being used to Clean a Crack (after, Smith and Romine, 1999)

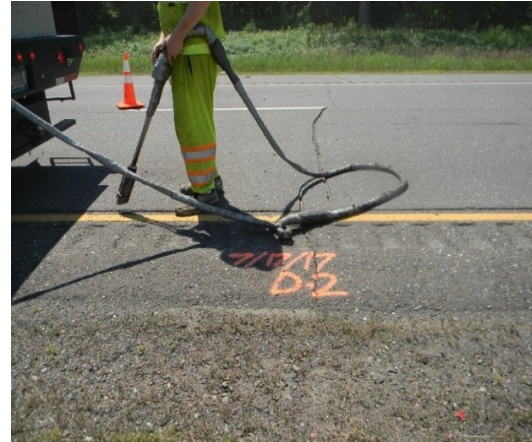
Figure 2.5: Air lance being used to Clean a Crack

**Air Lance:** Hot air blasting uses air that is heated to a minimum of 1,370° Celsius as defined by the Smith and Romine (1999). This form of cleaning is effective at removing dirt and debris. It also creates a dry and hot crack surface for a sealant to bond to. A hot surface will likely create a better bond for the sealant by activating the binder in the pavement itself. Caution must be used, however, as it is possible to burn the asphalt concrete pavement with a lance. For this reason, an open flame torch should never be used for this procedure. Figure 2.5 shows an example of an air lancing to clean a crack.

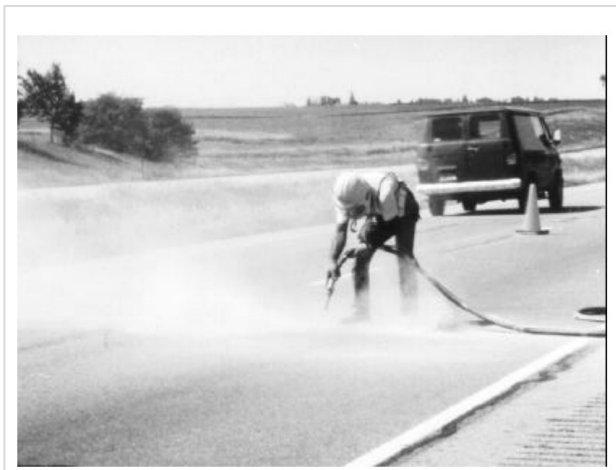
Figure 2.6: Sandblaster Being Used to Clean a Crack (after, Smith and Romine, 1999)

**Sandblaster:** Sandblasting is a highly effective way of removing debris and loosened fragments from the channel of a crack. One pass of the sandblaster should be made on each side of a routed reservoir. The procedure leaves a smooth and textured surface that is ideal for the sealant to bond to. Sandblasting consists of a compressed air unit, sandblaster machine, hoses, and a wand. A second pass with an air compressor is typically necessary to clean any debris that was left during the sand blast. Due to the number of passes needed, sand blasting requires a great deal of equipment, is labor-intensive, and time-consuming. Figure 2.6 shows an example of sand blaster being used to clean a crack.

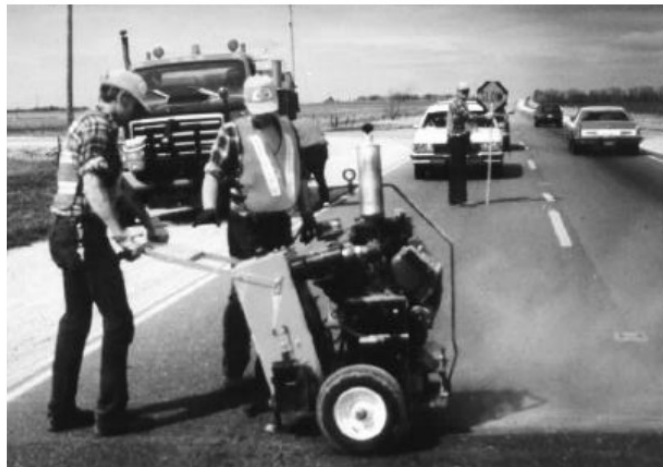
Figure 2.8: Routing Machine (after, Smith and Romine, 1999)

**Routing Machine:** Crack routing is performed by a worker using a router or saw unit mounted onto a cart. The operator uses his/her eyes and best judgment to follow the path of the crack with the routing or sawing machine. Smith and Romine (1999) noted that although a saw with a 150-200 mm diameter diamond blade can follow the meanders of cracks fairly well, the high cutting rate of an impact router creates smoother reservoir walls with a higher percentage of aggregate area for the sealant to bond to. Most companies require that employees operating routing equipment wear some type of respirator mask. The most modern routing machines have air and dust control systems built into them. Figure 2.8 shows an example of a router in operation.

The first step of performing the rout-and-seal crack treatment is routing the cracks. Routing machinery comparable to that shown in Figure 2.8 is used for this. Figure 2.15 shows a crack before and after being routed.

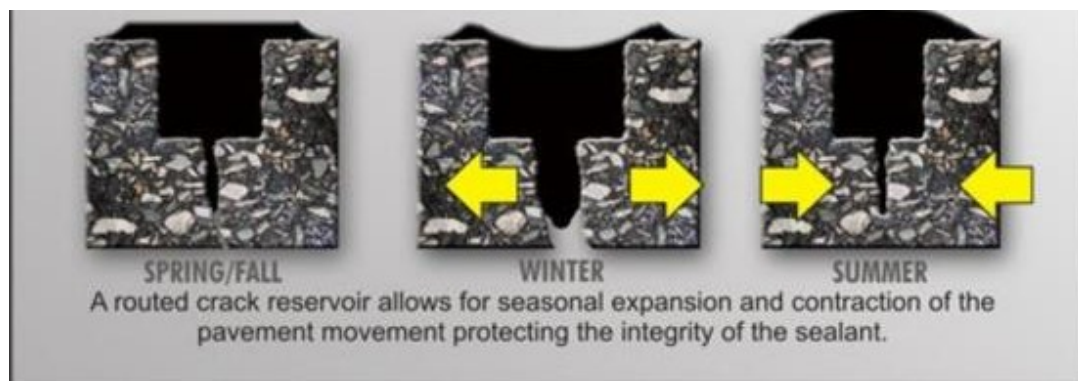
**Figure 2.14: Routed Seal Expanding and Contracting Without Failure (after, Stoikes, 2017)**

There are three major benefits of creating the reservoir. One benefit is that the saw routing machine removes a percentage of deteriorated material from the immediate area around the existing crack. This reduces the possibility of water entering hairline secondary cracks around the existing crack and causing continues deterioration. The second benefit of cutting a reservoir is that it creates a very cleanable and sealable surface. It is much easier for workers to blow debris out of a fresh cut reservoir than an existing crack with various irregularities in its geometric shape. The consistently clean sidewalls made by routing are a good surface for a sealant to bond to. The third and largest benefit of routing cracks is that the reservoir holds a large pool of sealant that has a larger ability to expand and contract with the pavement due to thermal fluctuations. See Figure 2.14.

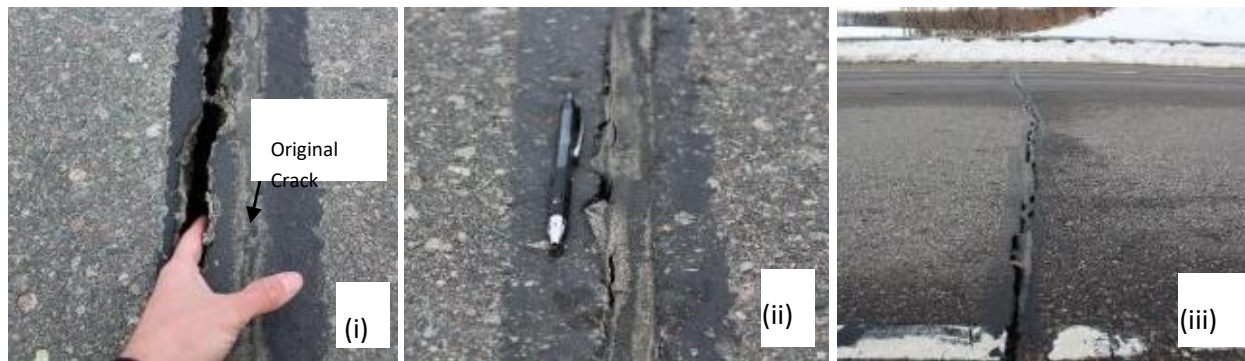
**Figure 4.28: Examples of Seal Failures (i) Spalling, (ii) Partial Adhesion Loss, (iii) Full-depth Adhesion Loss.)**

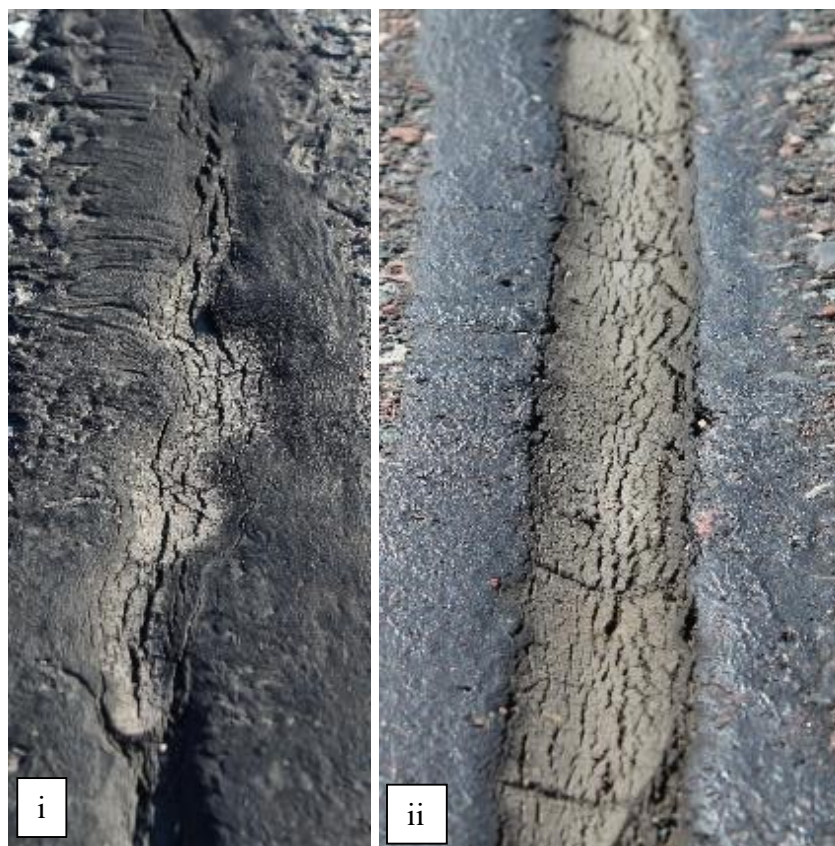
**Figure 4.29: (i) Cohesion Failure of Clean-and-Seal Crack (ii) Early Signs of Cohesion Failure on Rout-and-Seal Crack**

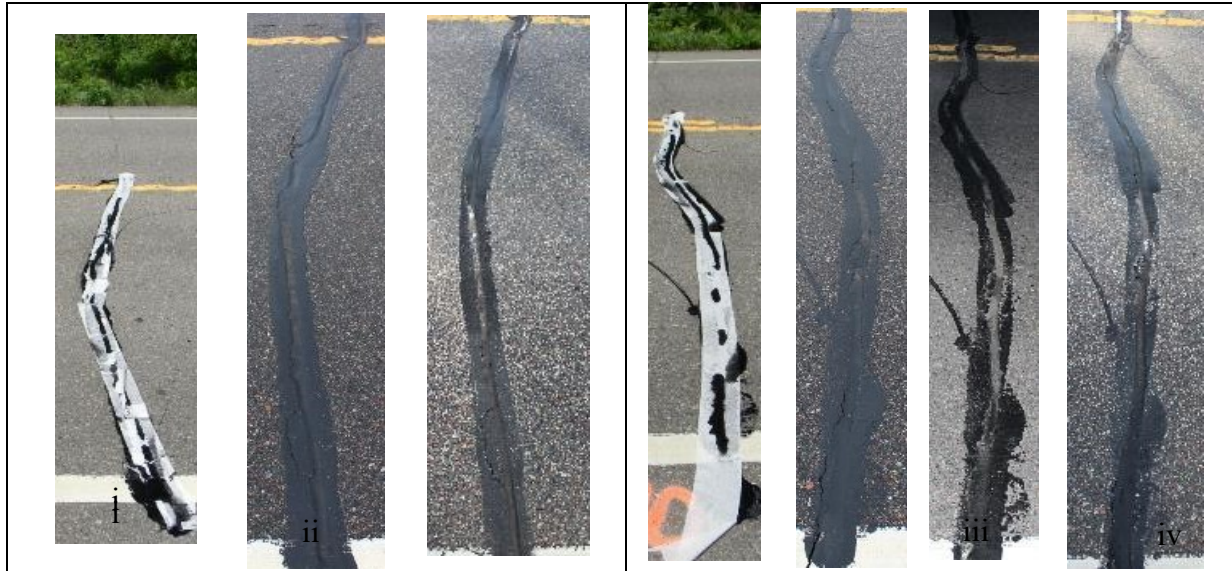
**Figure 4.32: Photographic Performance Documentation of Site E.** E-1-i Shows Crack E-1 upon being sealed. E-1-ii and E-1-iii show Crack E-1 at the end of its first winter and during the second winter after being sealed. This same sequence of photos follows for cracks E-2, E-3, E-4, E-5, E-6, E-7, E-8, E-9, and E-10. E-10-iv shows the seal performance at the end of the first winter compared to the mid-winter performance presented in E-10-iii.

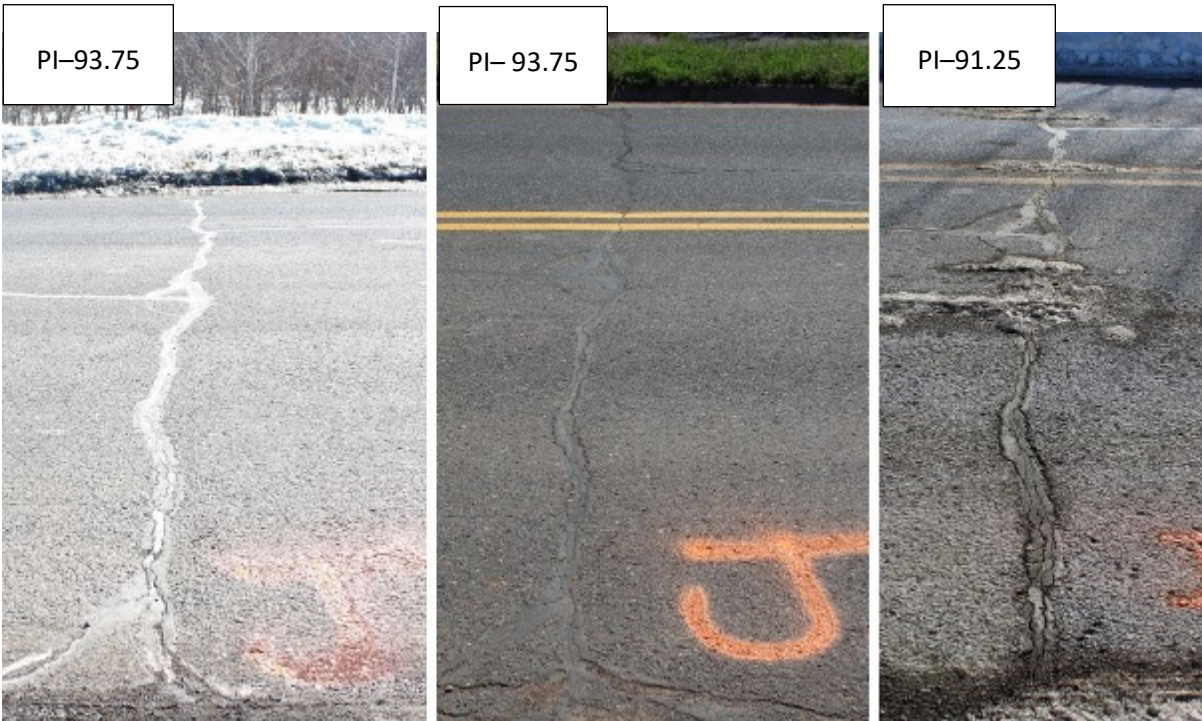
Figure 4.38: Site J- E Palm St., Duluth; Crack Sealing Year - 2014
